Arizona State University

Form: Fire Report

Inspection Type: **7 - Emergency Response.**
Inspection Date: **3/6/2022** By: Esperti, Chris J
Time In: **14:11** Time Out: **16:45**
Authorized Date: **03/11/2022** By: Esperti, Chris J

This Inspection Report is for situations associated with a reported Fire. This Report will be issued and reported as part of the Annual Security and Fire Safety Report "Clery Act".

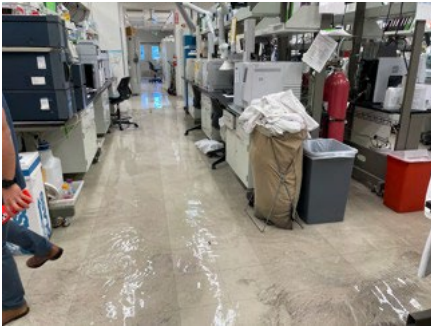
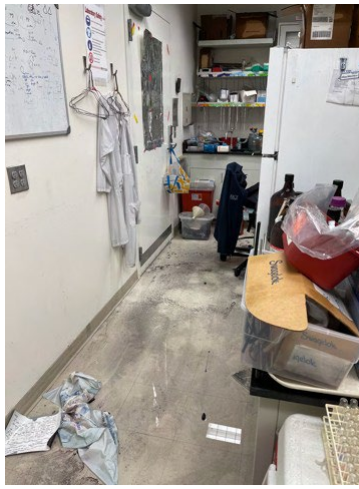
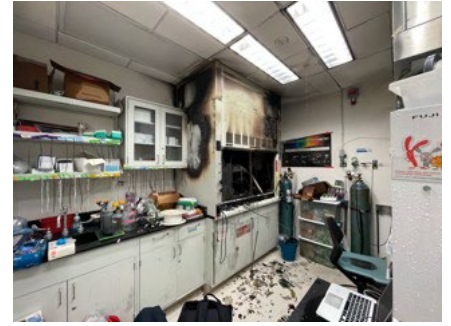
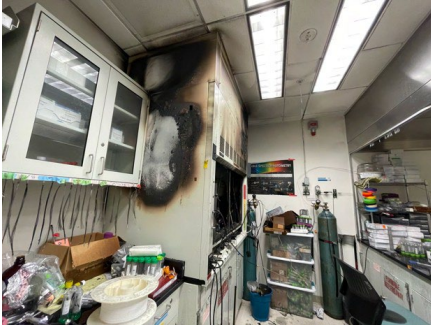
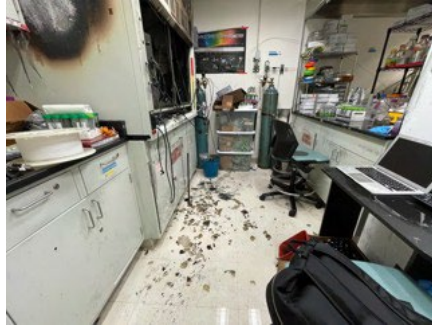
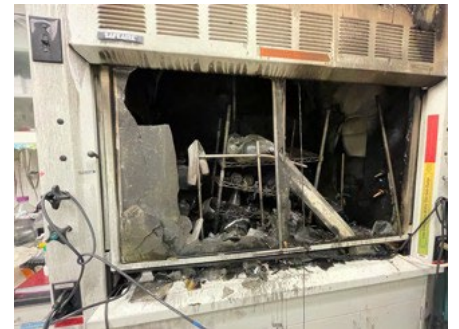
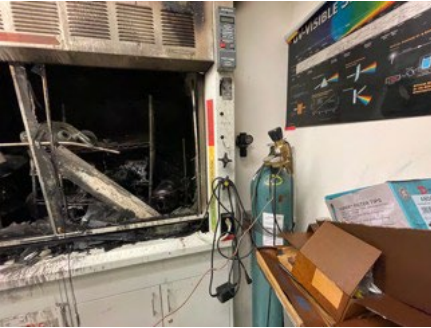
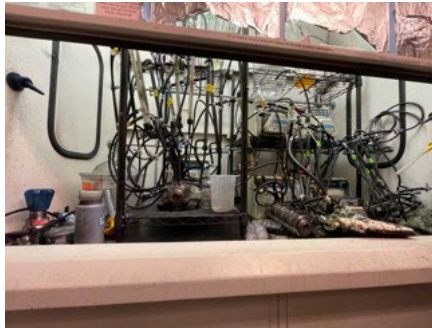
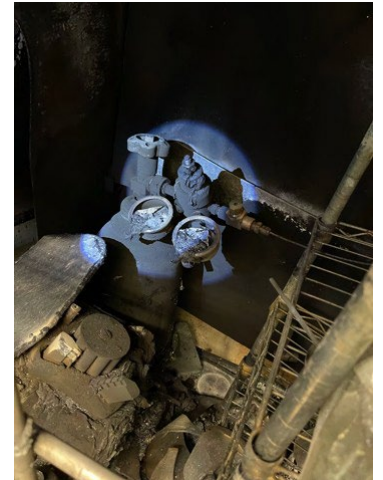
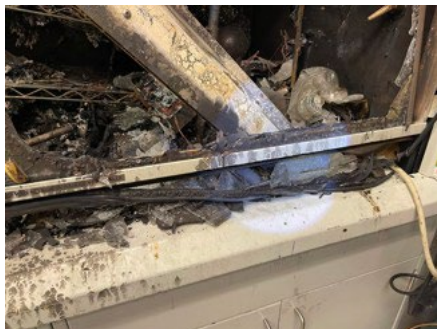
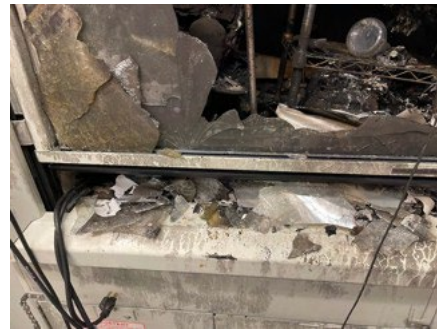
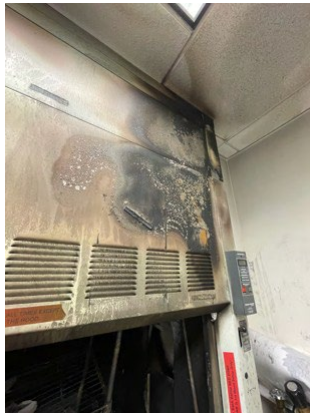
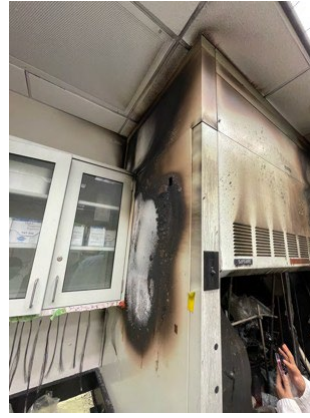
03/06/2022 - Upon entry into the outer Laboratory () there was standing water throughout this common Laboratory area (See Attachment 1 and 2, from Left to Right). Entry into the Laboratory Room () has two doors that enter into the space, facing the Laboratory the right side was unaffected but had standing water (Chemical Fume Hood still in operation) lighting was still active and ventilation throughout the space. The left side of () was the affected side, the Chemical Fume Hood was showing obvious signs that the fire was contained within the Chemical Fume Hood (Burned Paint and Heat Signatures on the Right exterior and upper Left exterior of the Hood), the glass sash shattered on the ground with an activated Sprinkler Head on the exterior of the Fume Hood (See Attachments 3 - 7 from Left to Right). There were multiple small vials of what was determined to be waste water within that were being dispersed amongst the standing water within the affected Lab and out into the main Lab areas. There were a total of 3 regulators identified within the Fume Hood and what appeared to be 5 pumps, one of the pumps on the lower left side of the Chemical Fume Hood was not entirely melted as were the remaining four. We looked at the unaffected Chemical Fume Hood as a rough example of how the Hood/experiment would have looked normally (See Attachment 8 from Left to Right). By looking at the unaffected Hood and speaking with the [Laboratory Principal Investigator] who accompanied us on the assessment. [Laboratory Principal Investigator] stated that they have glass tubing that within a fibrous material hydrogen gas is flowed through the top and bottom of these tubes within the hood. These tubes are connected with rubber tubing. There are electrical pumps within the hood (total of 5). The remaining shattered glass within the Hood are bottles that contained waste water as part of the experiment. The only flammable materials were the rubber tubing and the plastic components of the pumps. Hydrogen gas was being pumped in from the exterior of the Fume Hood through a stainless steel line (through the lower right side). The connection point of this stainless steel hydrogen line went to a rubber tubing and then into a regulator. The tubing was not present and could be seen to be melted around the existing stainless steel hydrogen tubing. As is mentioned in the interview section below [Unit Facility/Safety Staff] witnessed the smoke through the exterior door of () when the Fire Alarm was activated and secured the main Hydrogen Gas that fed the space. The inspection of the Hood did not show any obvious signs of malicious intent. There was no evidence of any incendiary device utilized to start this fire. There was an additional regulator in a blue bucket with a copper line laying on the ground in front of the affected Fume Hood (See Attachments 3, 4, and 5, from Left to Right). The regulator was identified during the interview with [Laboratory Principal Investigator] (see below) that he had mounted the copper tubing and regulator along the top exterior of the affected Chemical Fume Hood and the regulator hung down as a spare near the cylinders along the wall. The securing mechanism must have melted causing the tubing and the regulator to fall to the ground and into the blue bucket. Tempe Fire and Medical Rescue Fire Fighters were asked and confirmed by the Tempe Fire Investigator that they did not touch or move anything.

03/07/2022 - Re-entered Laboratory Room () with Robert Ott (EHS), Neha Chawla (EHS), [Unit Facility/Safety Staff], [Laboratory Principal Investigator], [Researcher 1], [Laboratory Manager], and [Researcher 2]. Closer investigation of the involved Chemical Fume Hood showed that the sash that had the shattered glass has a rubber gasket at the bottom that had shown signs of melting (flame impingement) on the right side of the Hood. The left side rubber gasket was still intact with not flame impingement (See Attachments 10 and 11, from Left to Right). The left side within the Fume Hood had a cylinder that is identified from previous pictures of the experiment setup and confirmation from [Laboratory Principal Investigator] that this cylinder is Nitric Oxide, cylinder valve by touch appears to be in the closed position. Cylinder has an attached regulator (one of the three identified within the Hood), there is no attached tubing to this regulator as it burned and melted away as part of the fire (See Attachments 9, from Left to Right). The heat signatures were better documented showing the upper right side exterior of the Hood (closest to the activated Sprinkler Head), and the upper left side exterior (See Attachments 12 and 13, from Left to Right).

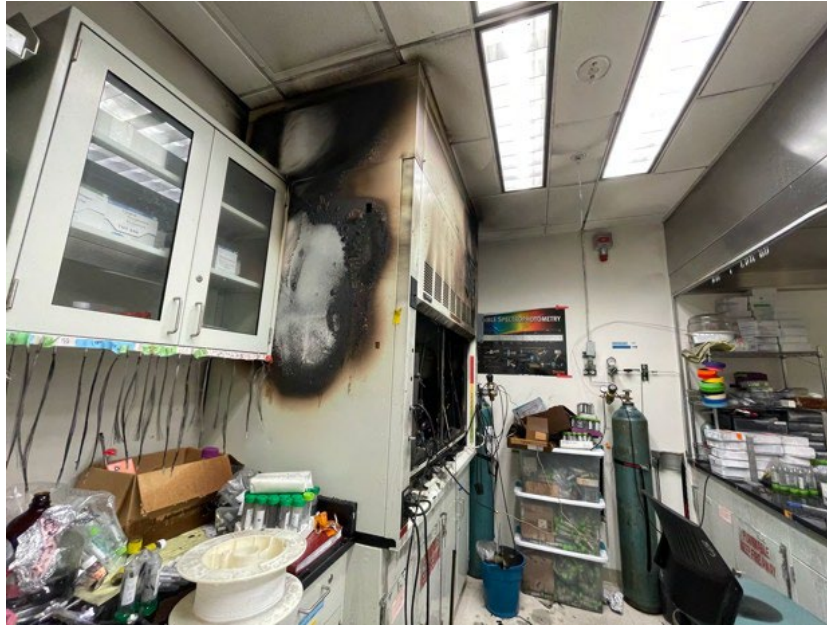
Notes: Sprinkler Head outside of the Fume Hood inside of Laboratory Room [REDACTED] was activated from Fire effects. NOTE - Upon entry of Laboratory Room [REDACTED] the Fume Hood on the Left is the affected Fume Hood with Sprinkler Activation.

Notes: ASU FSST Department (Dale Munday) contacted Arizona Verde Fire Protection along with ASU FSST (Brian Wabby). Arizona Verde replaced the affected sprinkler system and placed the Automatic Sprinkler System back in operation on 03/06/2022 at 7:07pm.
